Geothermal (aka Geoexchange) Heat Pump Installation Observations / Lessons Learned

1.1. Geothermal Ground Loop Installation – Observations from 8/1/2011 to 8/2/2011

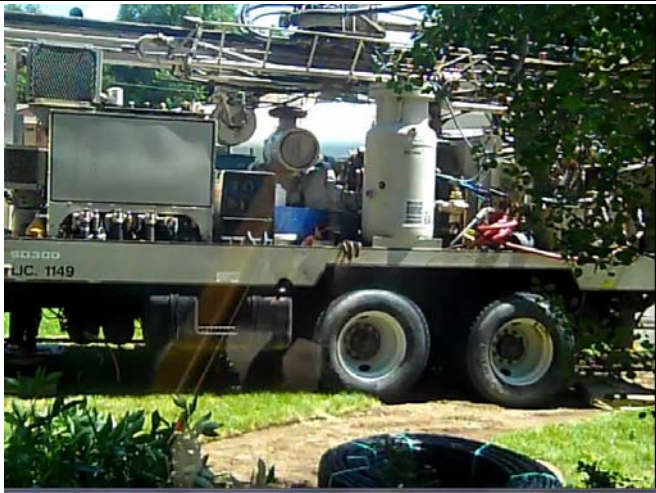
If you decide to install a vertical geothermal ground loop on your property, get mentally prepared for a drilling rig to show up in your yard. The strip of bare ground shows where we had stripped the sod between the locations of the two proposed "wells."

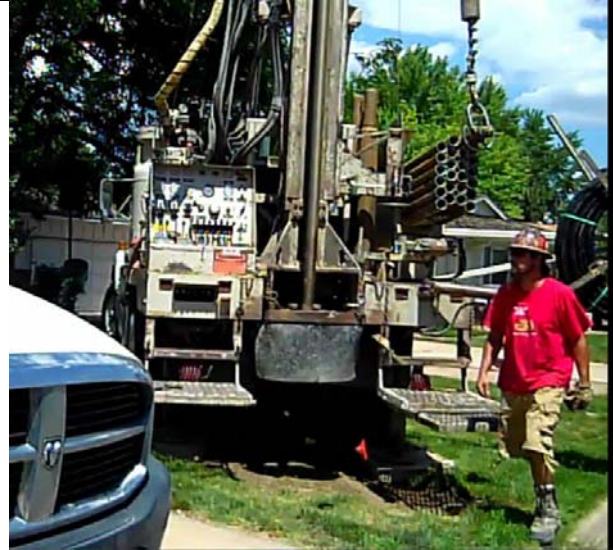
With the rig in place and erected, checkout proceeds

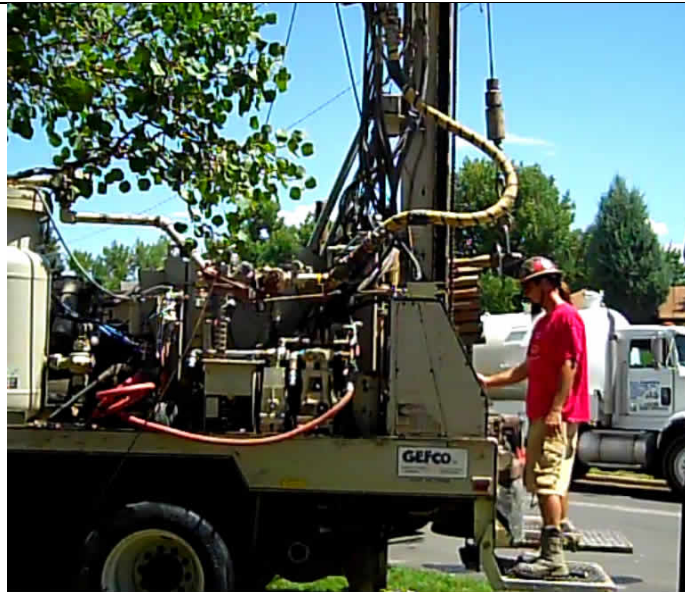
Last minute checks as drilling is about to begin

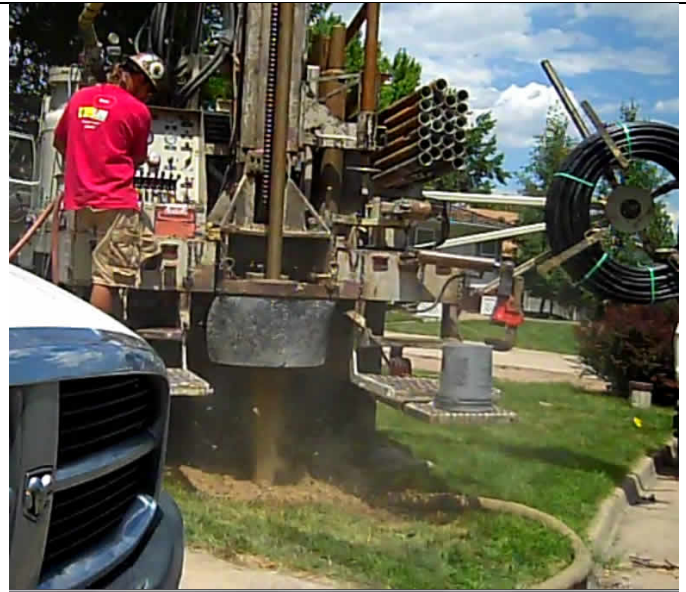
Drilling begins as high pressure water is forced into the drill pipe and out the lower end at the drill bit. The water is then forced back up the hole to emerge as a mud spray that impinges on the bottom of the platform (operator's knee level). The mud is then diverted by the black rubber shirt and falls back onto the ground around the hole. Notice the vacuum tube laying along the ground intended to vacuum up the emerging drilling mud.

The drilling was slowed significantly by the failure of the vacuum pump truck to handle the dirt / mud from the drilling process. The truck's vacuum system was not functioning properly that day. When set to high vacuum, there was virtually no vacuum generated, so the vacuum system was set to the lower range where it still functioned, but not very well. As a result, it required a lot of patience to slowly suck up the drilling mud/water that was being generated. But there was a significant quantity of drilling mud to remove. During the drilling, some overflowed into the street gutter that required significant clean-up all the way down to the corner of Jackson and Orchard.

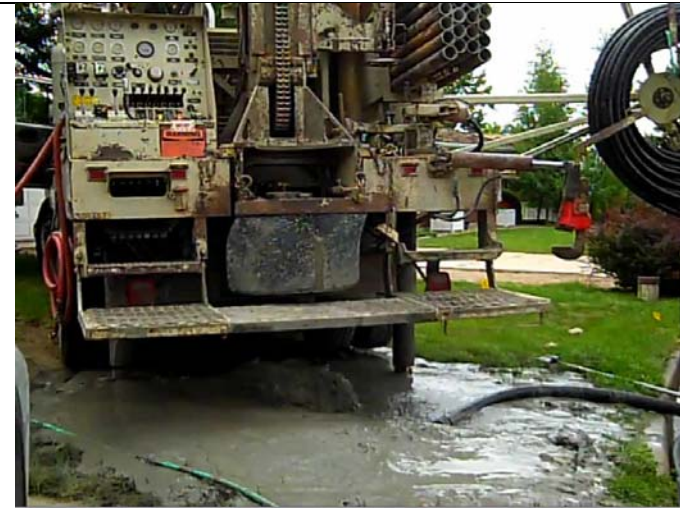
After about an hour and half, the drill bit had penetrated to about 300 feet (using 15 of the 20 foot sections of drill pipe). The drill pipe/bit has been raised back out of the hole. Now it's just a matter of dealing with the drilling mud.

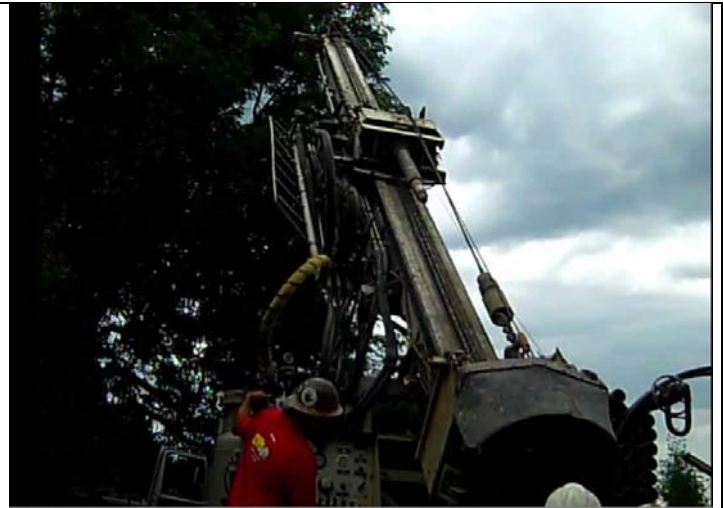
After the hole has been drilled, the boom is lowered - notice we provided some trees to make this a bit more challenging.

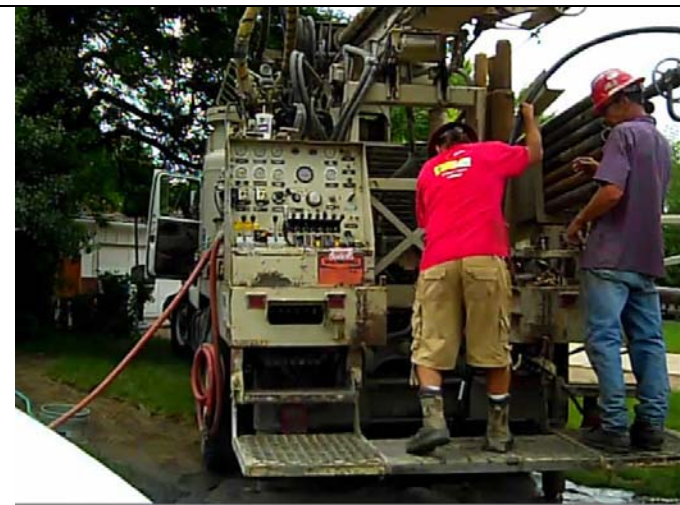
Before moving the drill rig, the 300 feet of double black plastic tubing is inserted down into the borehole from the spool to the right

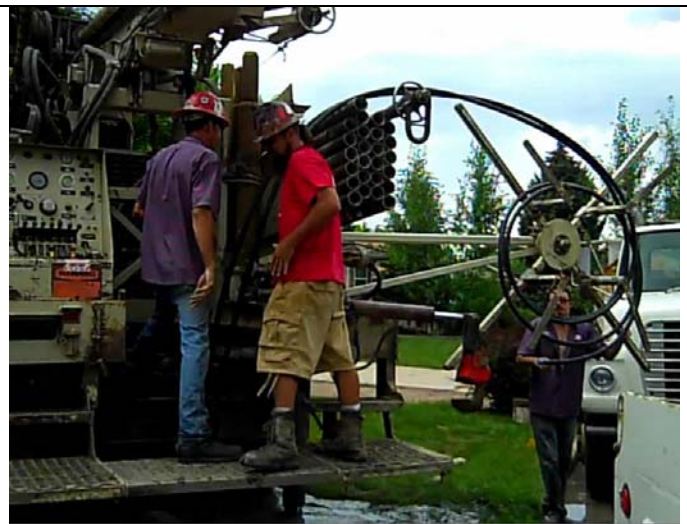
The black plastic 1" tubing is now in place. About 20 feet of excess tubing remains on the spool.

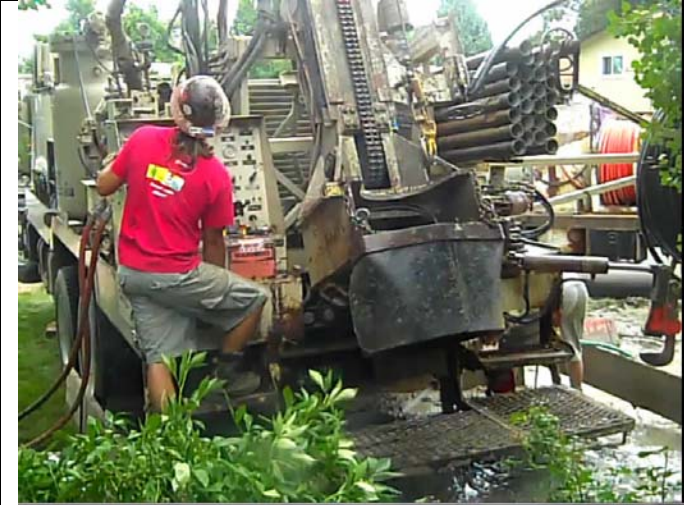
Hole # 2 was finished drilling around 10:35 am. The drill pipe was removed and the boom is being lowered. As indicated, there was a sea of mud that in this picture extends downhill to a temporary dirt dam at the street curb where the water is being sucked up by the hose from the vacuum truck.

There was a significant amount of dirt/clay/shale/mud (3- 4 wheelbarrows) left above ground around the second well (the malfunctioning vacuum truck was unable to handle it). The trenching crew that came later removed this excess material because we did not have a convenient way to dispose of it. There was no way this amount of material could be combined with the material dug from the trench between the two boreholes so that all the dirt could be replaced and end up with a level surface that can be re-sodded.

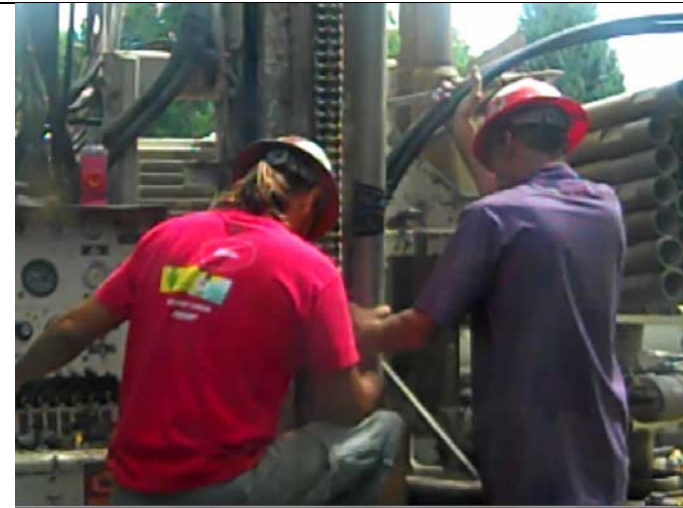
Again the drilling crew had some difficulty getting the black tubing to enter the hole, but it seemed to be going well up to about half way when the black pipe got tangled in the spooling mechanism and came to an abrupt stop causing one side of the dual tubes to buckle around a member of the spooling device. They immediately freed the tubing from the spool cross member and attempted to straighten the buckled tube by using a clamping device at 90 degrees to the bend to remove the buckling. They then proceeded to resume lowering the black pipe into the hole. It was going down properly until the last 40 feet (260 feet was in the hole) when it stopped. They assume they had encountered water and filled the black pipe with water to offset the buoyancy. This procedure helped only slightly. There was obviously mud/sand/gravel at the bottom of the borehole they were trying to push the black plastic tubing through at that point.

The black plastic is being inserted. On this hole, apparently material fell back into the bottom of the hole making it difficult to insert the last 25 feet of tubing. The tubing was taped to a section of drill pipe in an unsuccessful effort to drive it further down

The plastic pipe in well #2 should have been pressure tested to assure no leak was introduced when the black pipe was inadvertently kinked. It was not clear if the inadvertent buckling/kinking of one of the black pipes affected its local strength.

In retrospect, I should have recommended that 1.5 x normal operating pressure be applied as a proof pressure that the 1" black plastic was not compromised to where it can cause a future failure in the ground loop. I would even have accepted a pressure test on a scrap piece of black pipe that had been buckled / kinked to where it was closed and then crimped to restore its shape. There was no pressure test to verify the integrity of the buckled tubing. The general contractor did however ask the Geothermal trenching contractor to conduct a simple test to assure the tubing was not completely buckled and would not flow water. Water did flow through the buckled line – demonstrating it was not completely blocked.

- 2) As the black plastic tubing was inserted into one of the boreholes, an out of control spooling mechanism caused the tubing to become kinked. This seems like a bad thing to have happen, but the incident was not acknowledged, inspected, or even recorded by the driller. The tubing was not pressure tested (at say 1.5 times the operating pressure) to verify the kink placed in one of the lines during installation did not damage the integrity of the tubing.

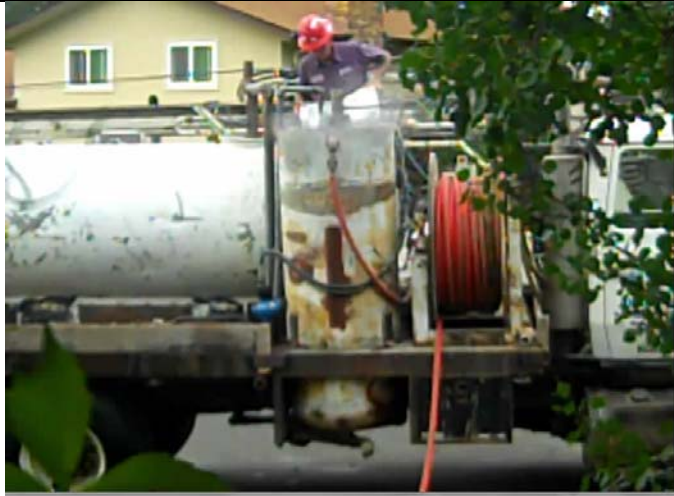
The operator of the grouting truck pours bags of thermal grout into the mixing chamber as they prepare a batch of grout (environmentally friendly bentonite clay).

- 3) The grouting process seemed to have few standards. There did not appear to be any consideration for those regions where the borehole encountered water during the drilling process. The actual grout mixture also seemed uncontrolled as far as the mixture of sand, grout and water is concerned. Our contractor appeared to use grout consisting mostly of bentonite clay in our boreholes.

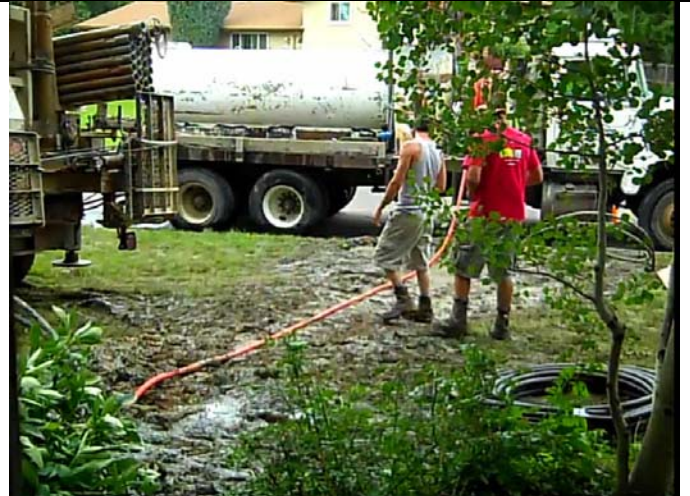
The last step for the drilling crew is to "grout" the tubing. A bentonite clay / sand mixture is used as the grout to fill in the space around the tubing and provide a heat transfer path between the tubing and the ground. The orange pipe is inserted down the well to the bottom and the grout is injected – the orange hose is then slowly pulled upward as the hole fills with the grout – eventually the grout starts oozing out the top of the hole.

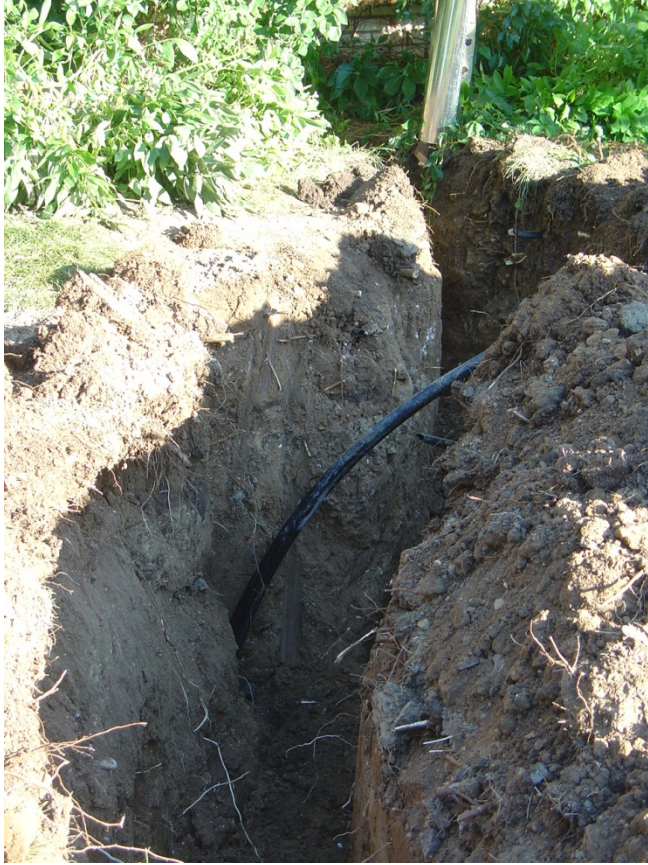
Ready to start connecting the two ground loops together

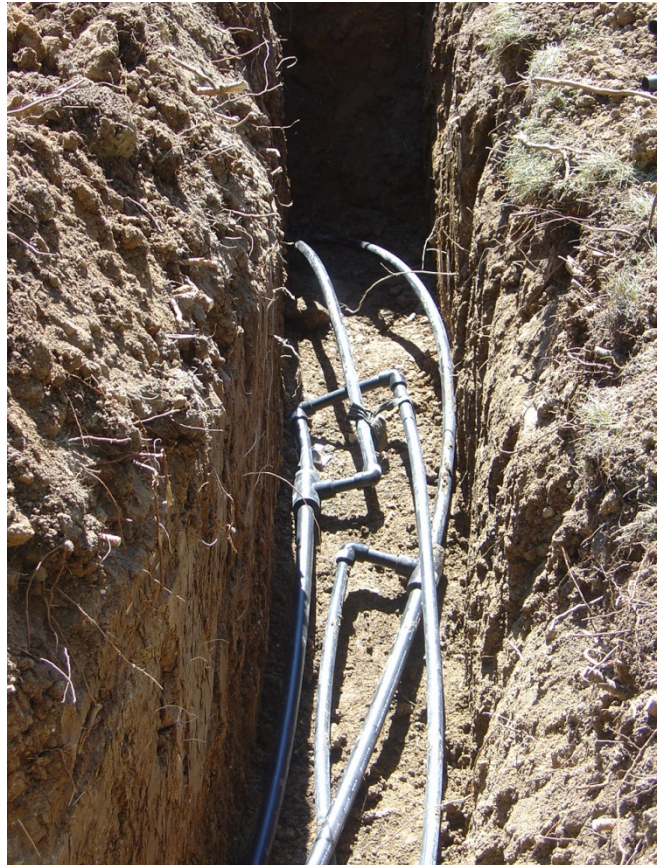
Manifold in place, soon to be tested for leaks and then the trench will be backfilled.

- 7) There was no confirmation of any leak rate or pressure change during the week or so the ground loop was locked up at an elevated pressure by the trenching crew.

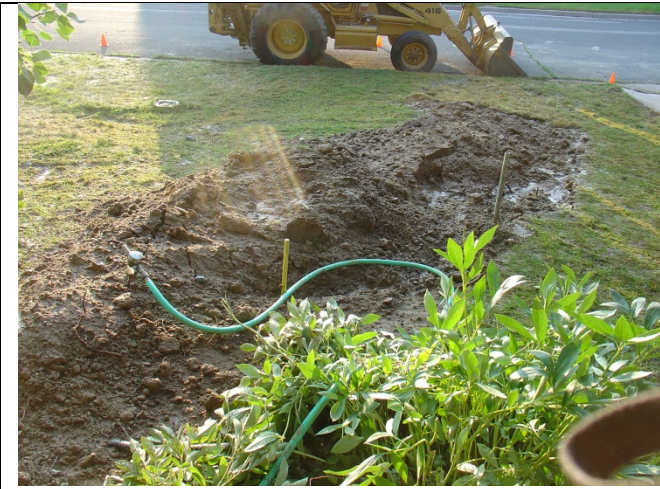
The trench was back filled by the contractor using the backhoe to pack the soil back in the trench, but there was a significant amount of soil left mounded above ground. After a day or so of deep watering (to where the dirt in the trench was nearly liquid all the way down to the bottom,) the mound did settle several inches but it was clear that another approach was needed before we could lay the original sod back down. So we decided to simply turn a portion of the trenched area into a mounded perennial plant/flower bed with a paver border that makes it appear this is what we intended to do all along. Perhaps in a year or so, the soil will have compacted and the flower bed will again be level with the rest of the yard, or not.

After a day or so of deep watering, it was clear we were still going to have a mound of dirt.

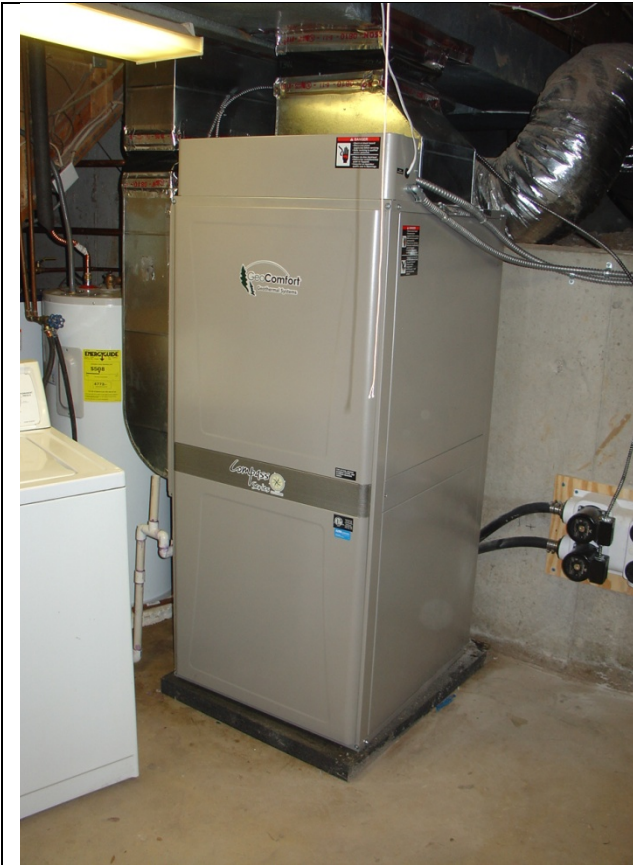
The new Heat Pump Furnace replaces the original natural gas burning furnace. Because the GeoExchange technology does not burn any fuel (fossil or bio), there is no need for an exhaust flue / chimney. So much for Santa Claus, sorry kids.

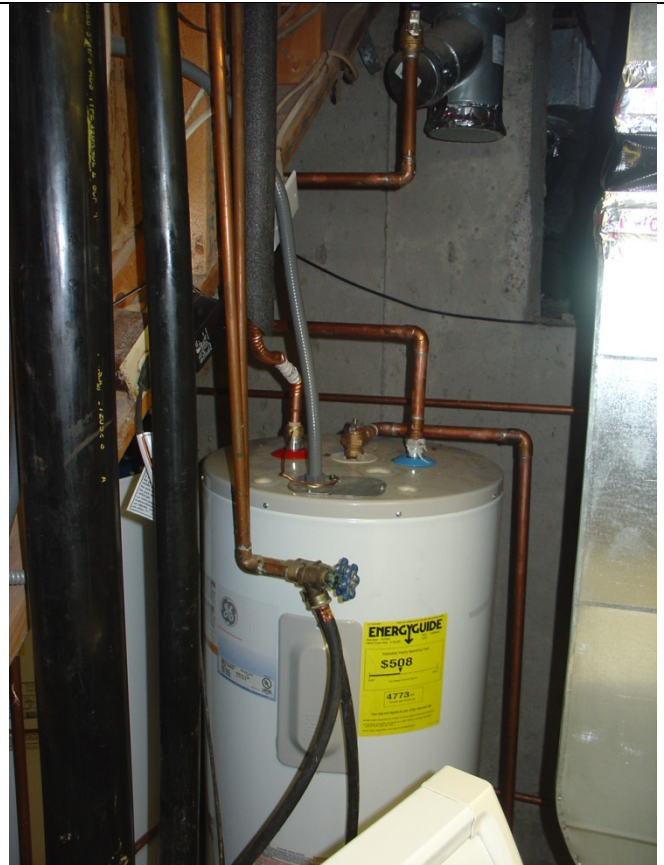
The Heat Pump system also preheats/heats water – a second preheat tank was tucked behind the primary electric hot water tank.

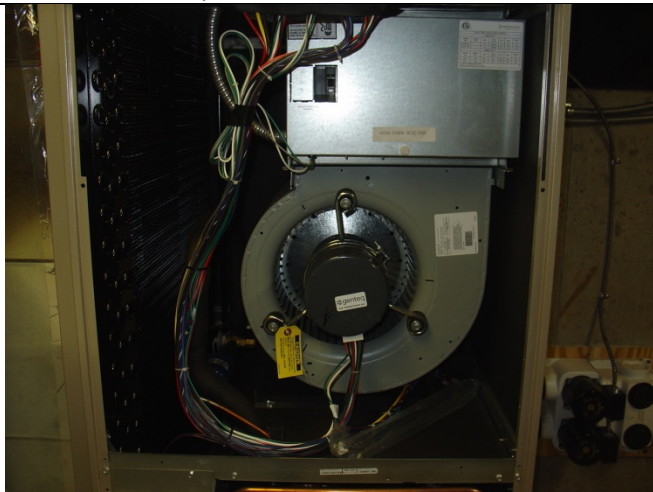
The Heat Pump Furnace assembly is much like a gas-fired furnace in that it uses the same cold and hot air ductwork, and a fan/blower to circulate cold and hot throughout the house. This photo with the furnace cover removed, shows the blower assembly where air from the "cold air" register enters on the left side and exits through the "hot air" plenum at the top of the photo.

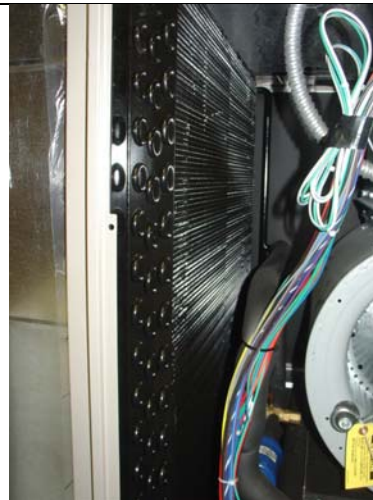
A closer look shows that the "cold air" is pulled through a heat exchange radiator by the blower assembly. The radiator temperature is controlled by the heat pump compressor – notice there are three layers of small black coils looping around the radiator. The fluid circulating in these small tubes is either hot or cold depending on how the heat pump is being driven – i.e. whether the house is being heated or cooled.

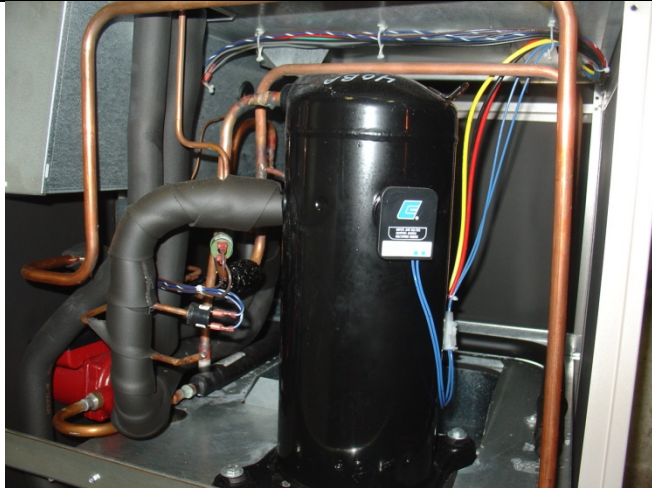
The compressor for the heat pump is directly below the blower assembly.

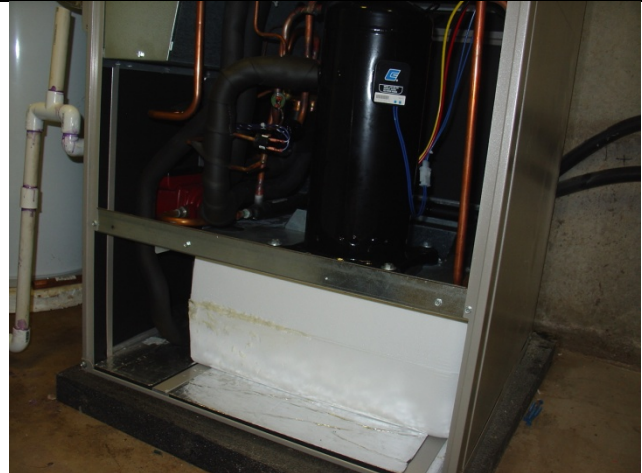
The ground loop coils are positioned just below the heat pump compressor (inside the styrofoam) for heat exchange with heat pump. No combustion anywhere – just the circulation of fluids that allow the house to exchange energy with earth – sustainably. No fossil fuel is consumed; zero emissions into the atmosphere.
